## ADDENDUM NO. 3

DAVIDSON ELEMENTARY SCHOOL - SINGLE POINT ENTRY

RCA Job No. 1-78-26

**Subject:**            ***Limited Asbestos, Lead & Hazardous Materials Assessment Report, Rev. 02  
Davidson Elementary School  
2844 Davidson Avenue – San Bernardino, CA  
EFI Job Number: 045.02871***

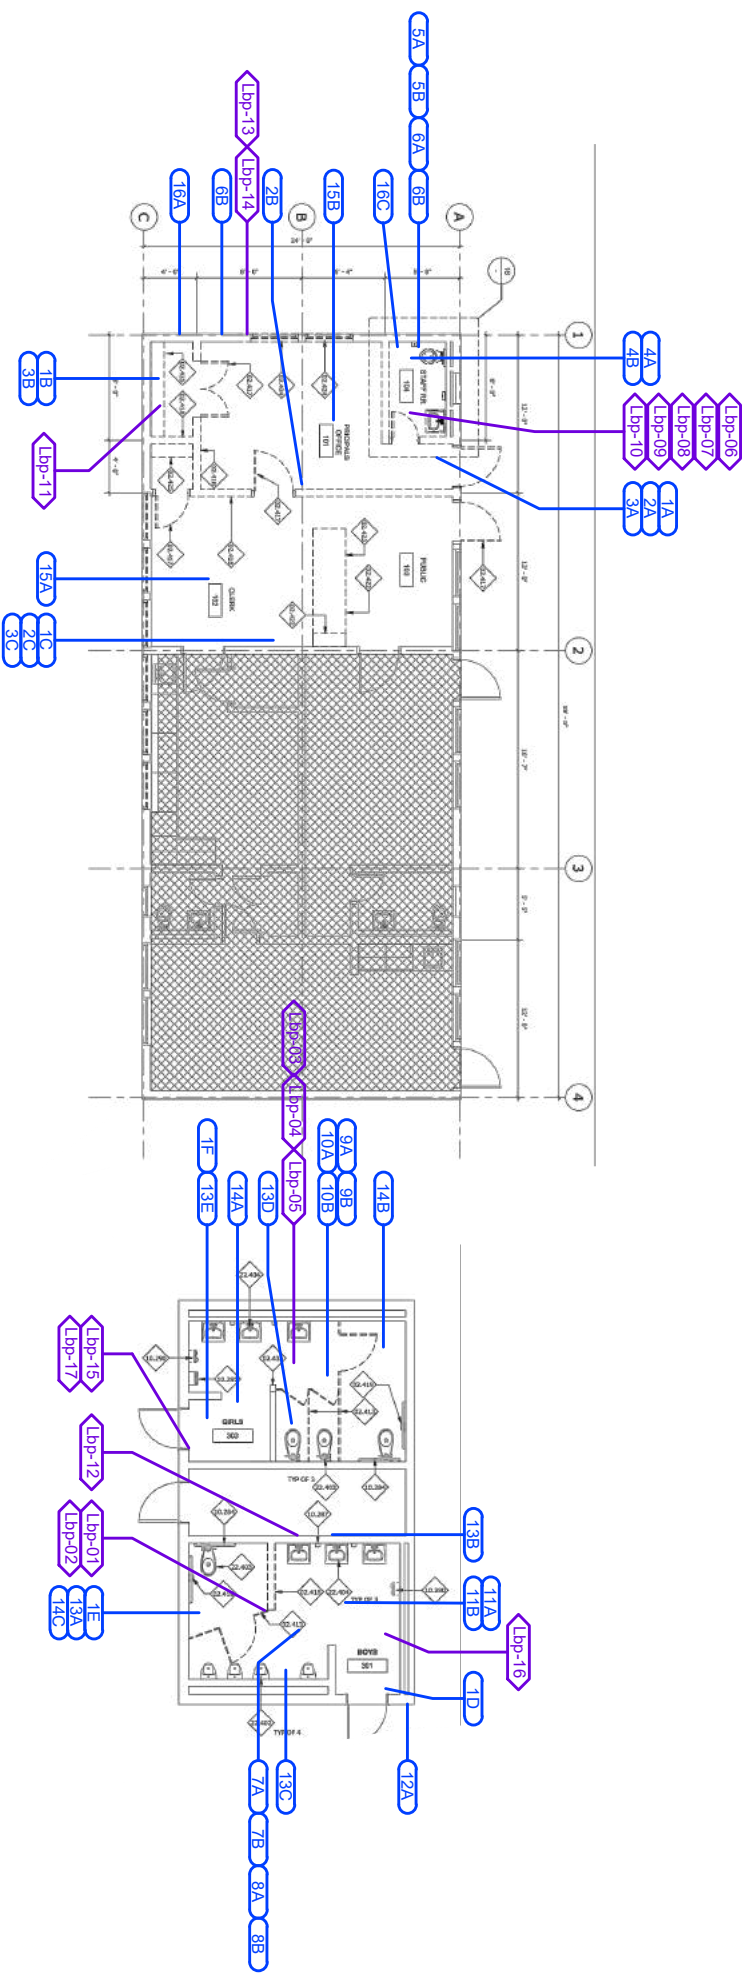
**APPENDIX I**  
**Site Diagram**

with a unique identification number. The sample number, description and location were then recorded on a log and plotted on a floor plan of the Project Area. Sampling tools were cleaned after collecting each sample. Any excess dust or debris from the sample location was cleaned using a moistened cloth. Whenever possible, samples were collected from previously damaged portions of the material in order to minimize damage to the material.
